Eurasian watermilfoil confirmed in Lake Orono

Point-intercept Macrophyte Survey
Lake Orono
Sherburne County, MN
July 21, 2020

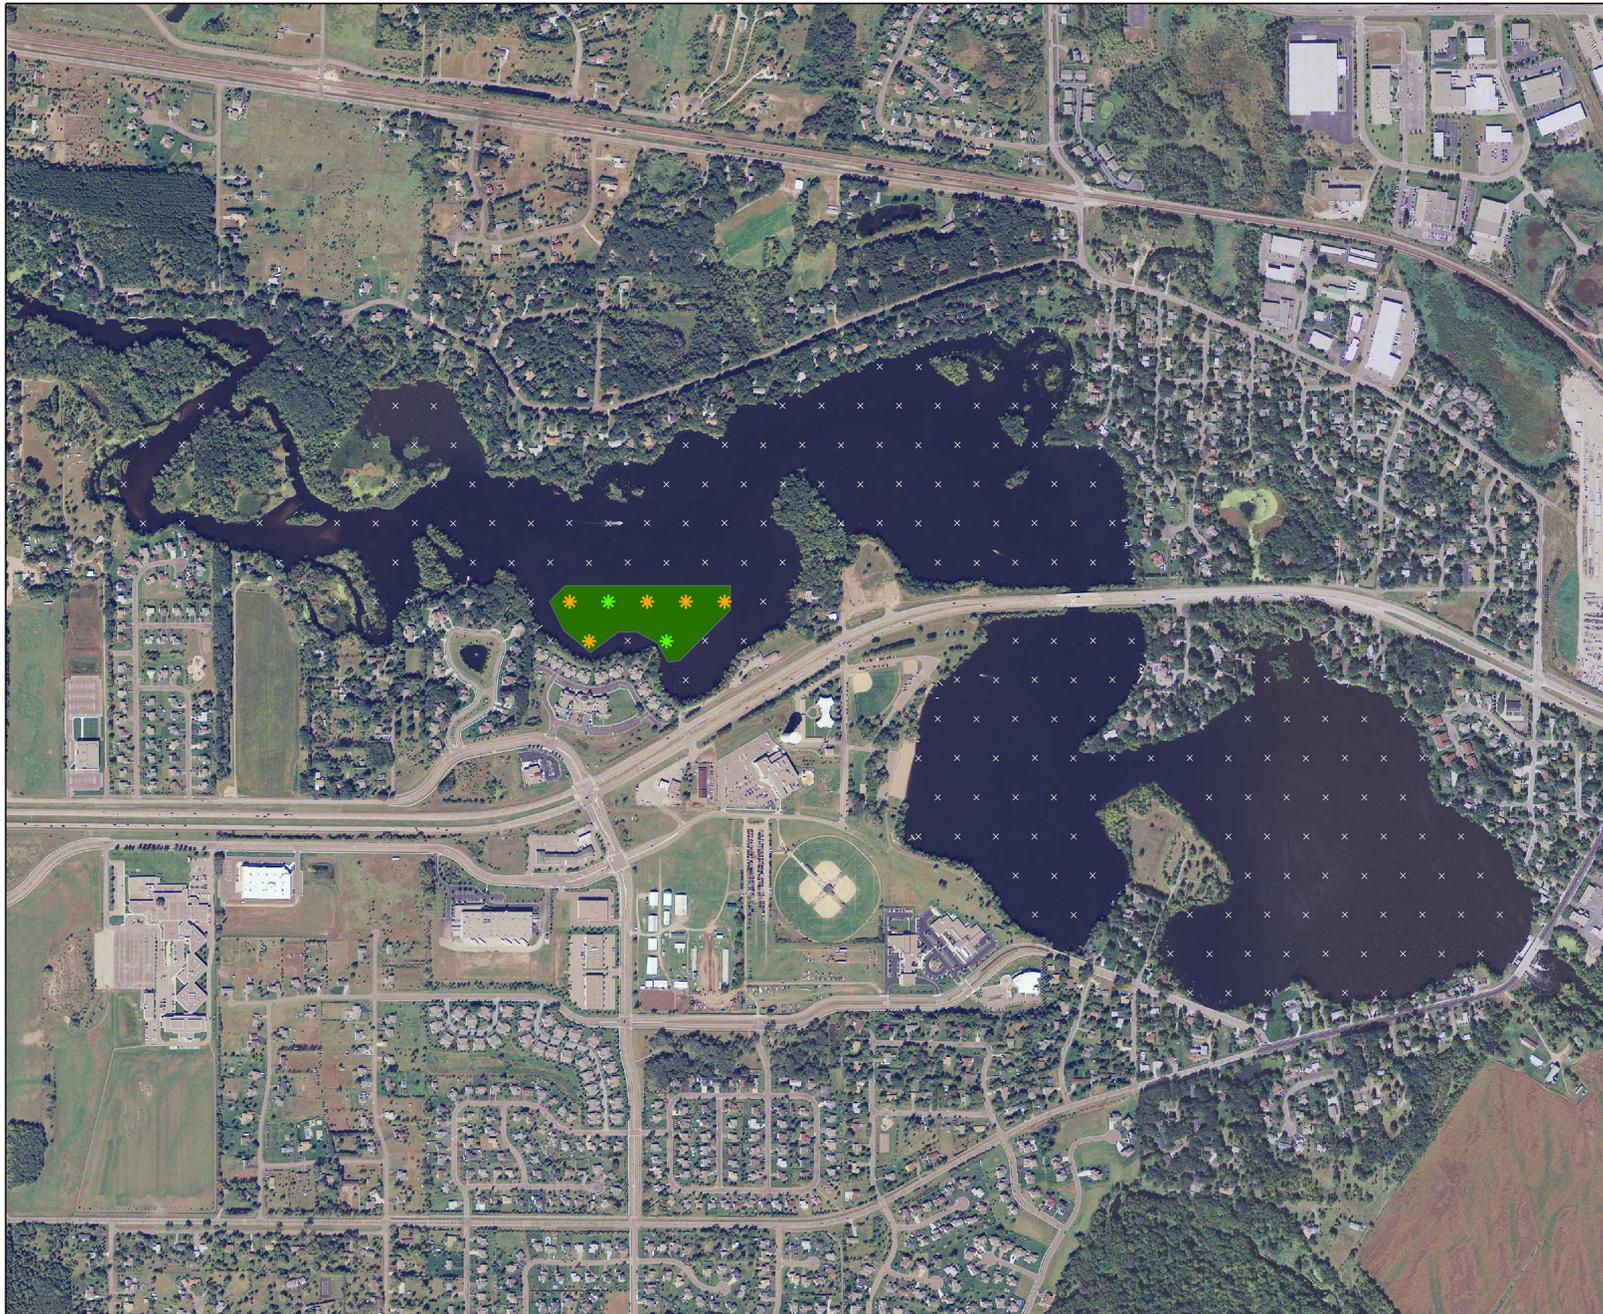
EWM was discovered in the river channel of the southern bay of the western upper portion of Lake Orono (Guardian Angels bay—see attached map). The infestation was beyond that which could be hand-removed efficiently.

Rake Fullness Rating

- * Visual
- * 1
- * 2
- * 3
- × None Found

Eurasian water-milfoil (*Myriophyllum spicatum*)

Please DO NOT boat in this area and warn your neighbors. Fragments of Eurasian watermilfoil can reproduce exponentially and spread to other areas by hitchhiking on watercraft.

There are DNR-approved herbicides that can be used to control EWM. The partnership listed above is examining options for treatments in hope that an aggressive approach can greatly reduce the existing plants as well as control the area. The infestation could have happened within the last two months, as EWM was not found in our first spring survey. That is how quickly this new threat spreads and though the dredging project may eradicate some of the EWM, it will not eliminate it. All studies show that acting rapidly is best way to limit widespread outbreak and the most cost-effective approach.

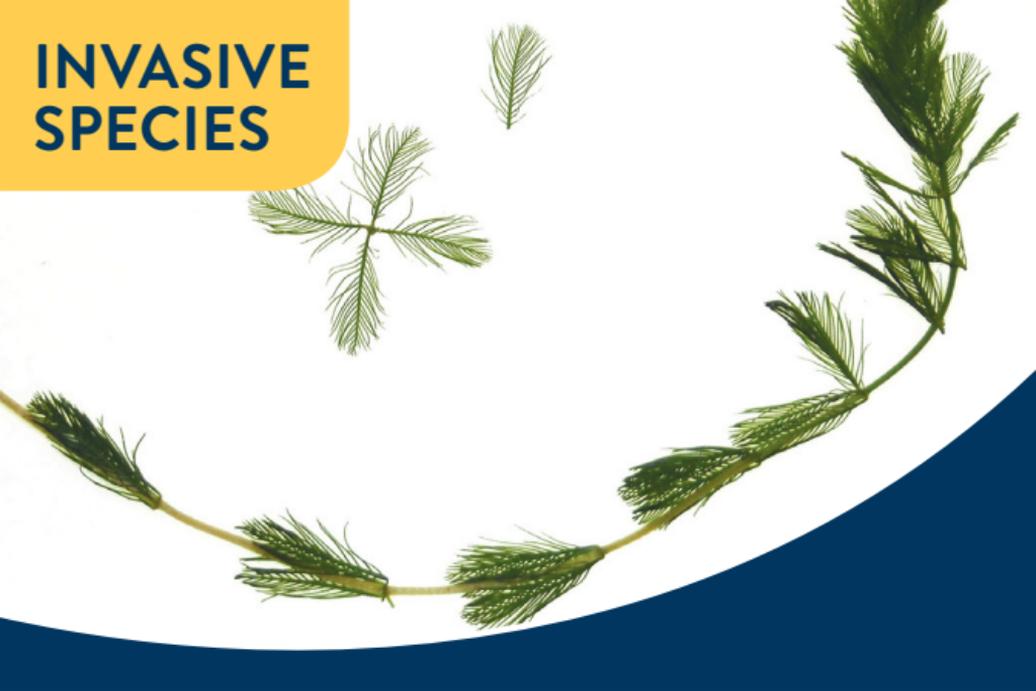
Eurasian Watermilfoil (*Myriophyllum spicatum*)

Characteristics:

- Submerged, limp aquatic plant
- Whorls (circles) of four delicate feather-like leaves around stem
- Usually 12 to 21 leaflet pairs per leaf

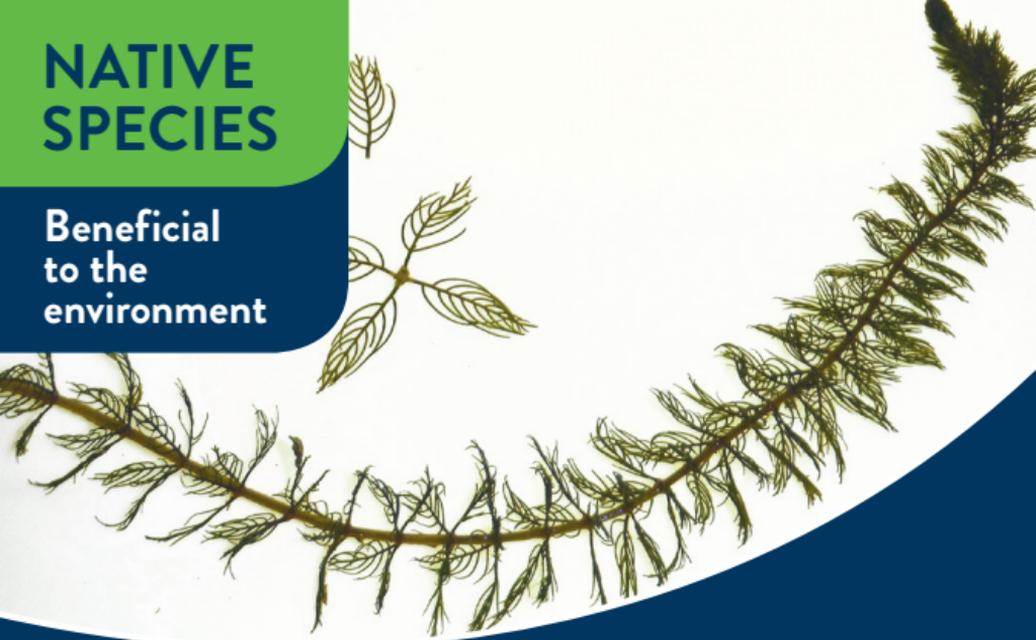
Northern Watermilfoil (*Myriophyllum sibiricum*)

Characteristics:

- Submerged, stiff aquatic plant
- Whorls (circles) of four rigid feather-like leaves around stem
- Usually 5 to 10 leaflet pairs per leaf
